### The Decision to Launch the Space Shuttle Challenger

ON January 28, 1986, the space shuttle Challenger exploded and seven astronauts died because two rubber O-rings leaked.<sup>22</sup> These rings had lost their resiliency because the shuttle was launched on a very cold day. Ambient temperatures were in the low 30s and the O-rings themselves were much colder, less than 20°F.

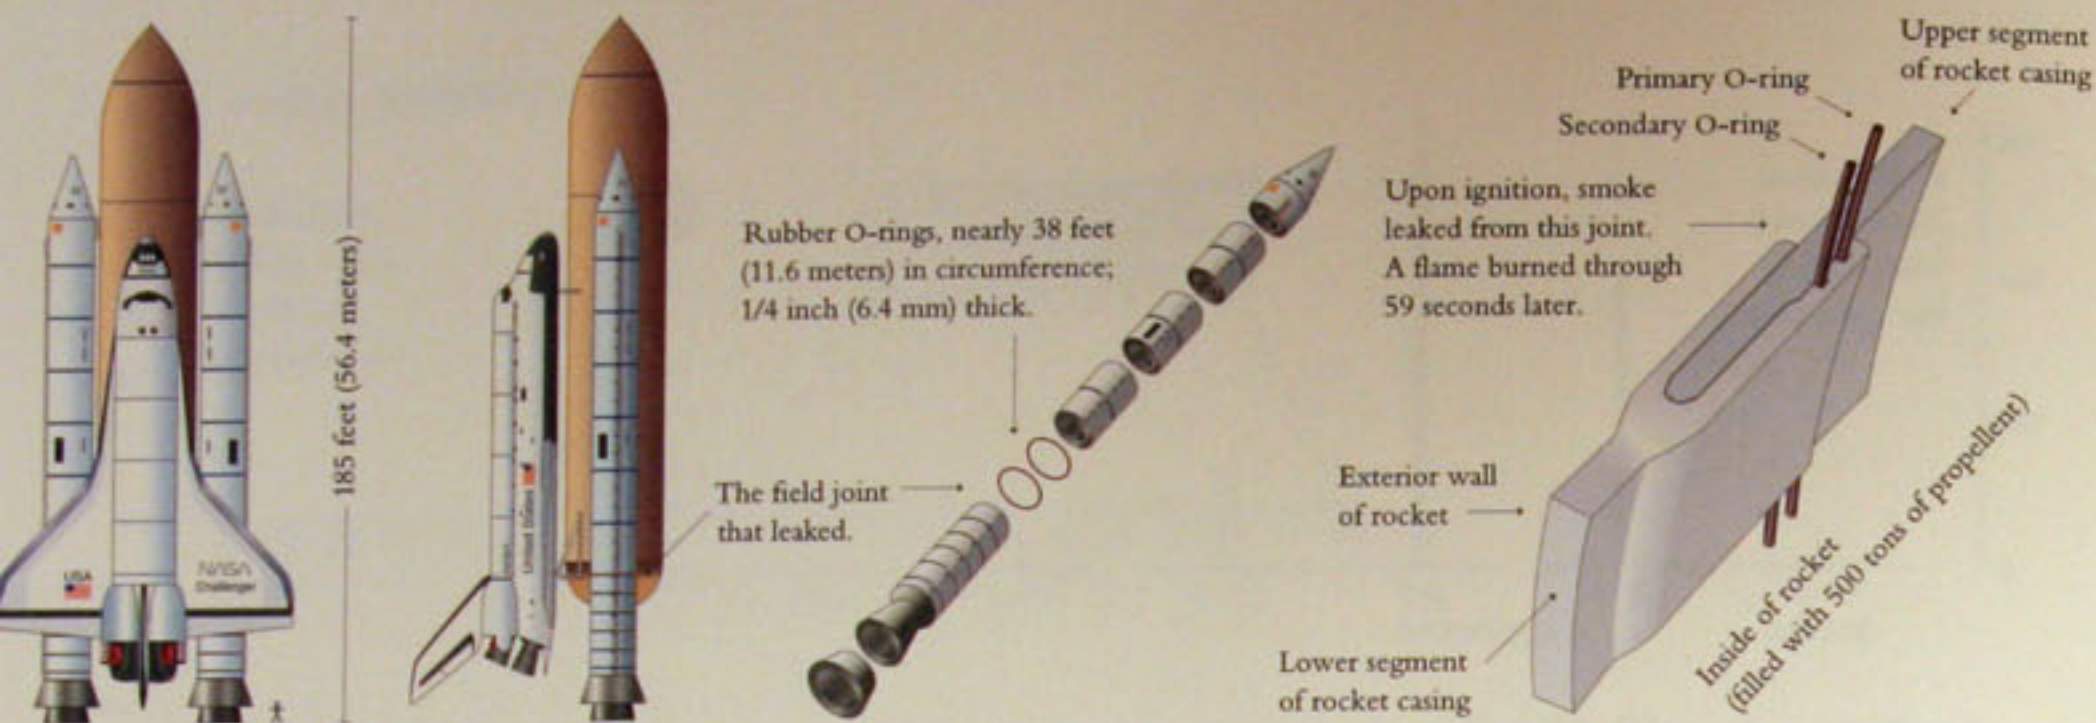
The shuttle consists of an orbiter (which carries the crew and has powerful engines in the back), a large liquid-fuel tank for the orbiter engines, and 2 solid-fuel booster rockets mounted on the sides of the central tank. Segments of the booster rockets are shipped to the launch site, where

they are assembled to make the solid-fuel rockets. Where these segments mate, each joint is sealed by two rubber O-rings as shown above. In the case of the Challenger accident, one of these joints leaked, and a torch-like flame burned through the side of the booster rocket.

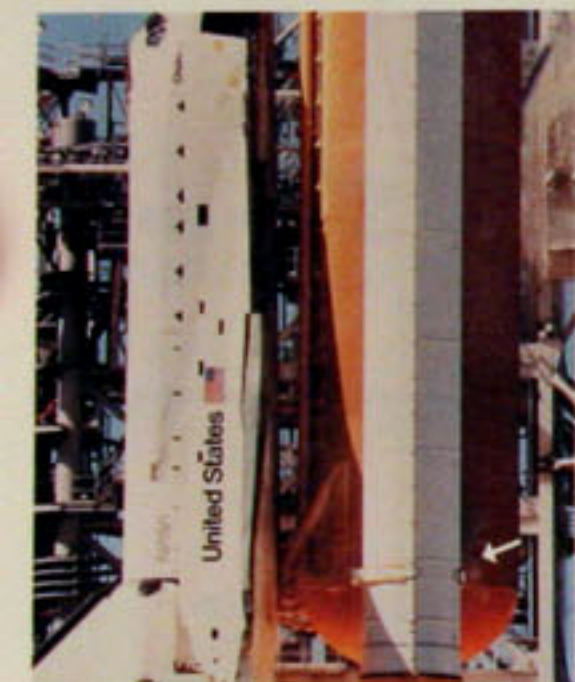
Less than 1 second after ignition, a puff of smoke appeared at the aft joint of the right booster, indicating that the O-rings burned through and failed to seal. At this point, all was lost.

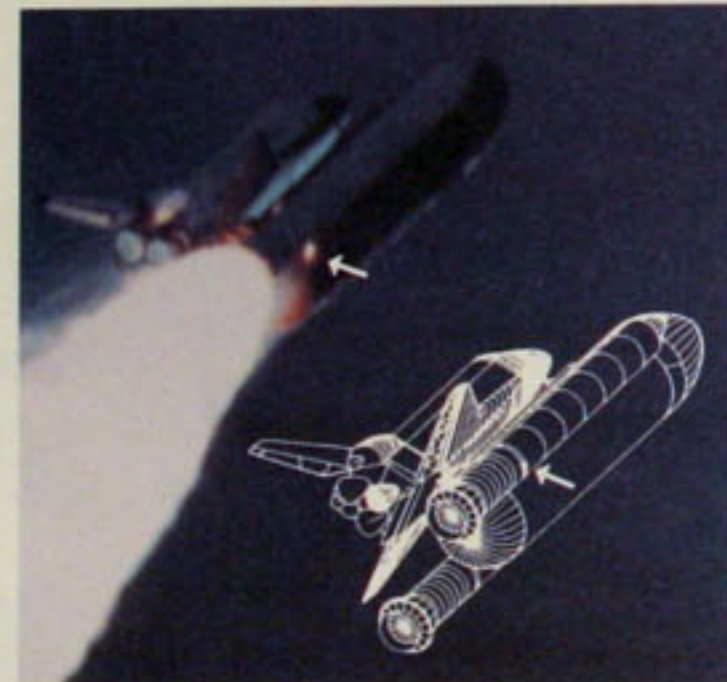
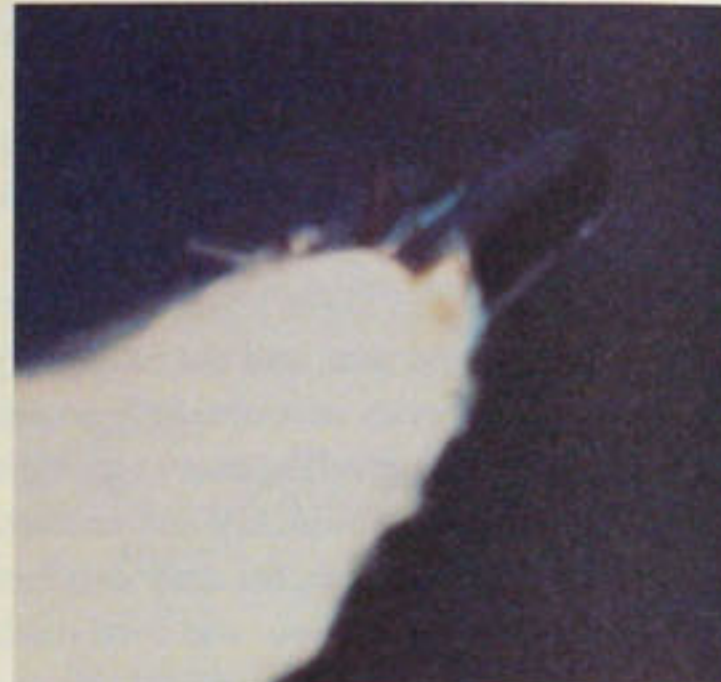
On the launch pad, the leak lasted only about 2 seconds and then apparently was plugged by putty and insulation as the shuttle rose, flying through rather strong cross-winds. Then 58.788 seconds after ignition, when the Challenger was 6 miles up, a flicker of flame emerged from the leaky joint. Within seconds, the flame grew and engulfed the fuel tank (containing liquid hydrogen and liquid oxygen). That tank ruptured and exploded, destroying the shuttle.

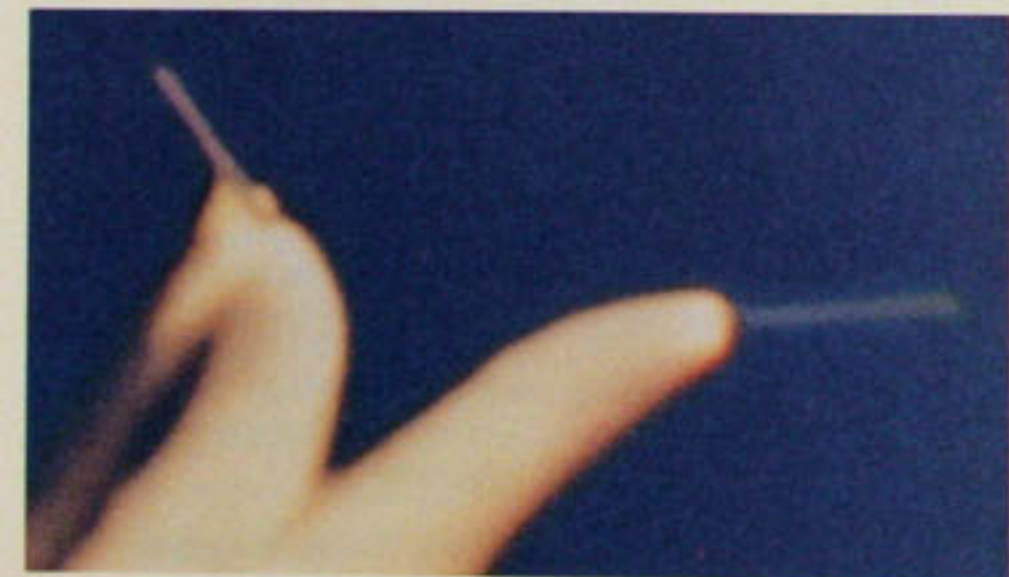
As the shuttle exploded and broke up at approximately 73 seconds after launch, the two booster rockets crisscrossed and continued flying wildly. The right booster, identifiable by its failure plume, is now to the left of its non-defective counterpart.

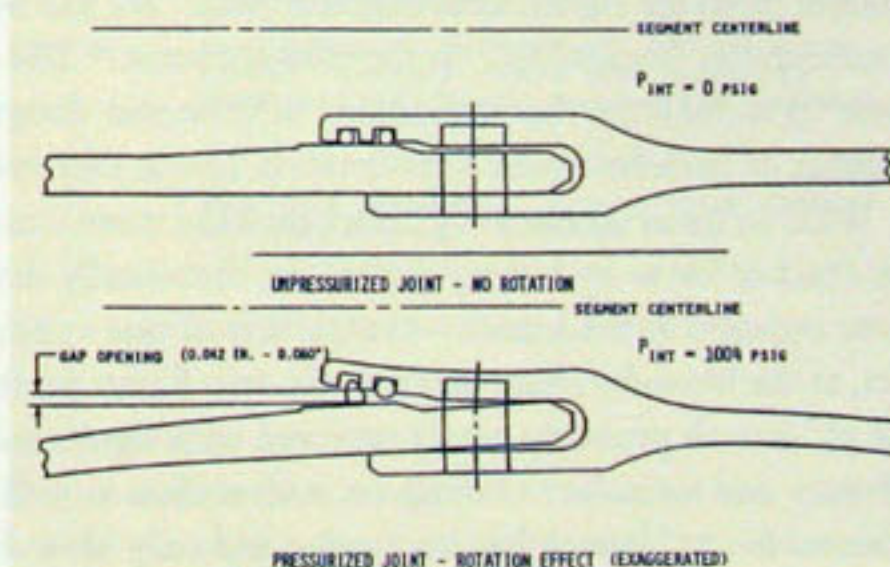
PRIMARY CONCERNS - CONT

The next chart (below left) describes how erosion in the primary O-ring interacts with its back-up, the secondary O-ring. Then two drawings (below right) make an effective visual comparison to show how rotation of the field joint degrades the O-ring seal. This vital effect, however, is not linked to the potential cause; indeed, neither chart appraises the phenomena described in relation to temperature.

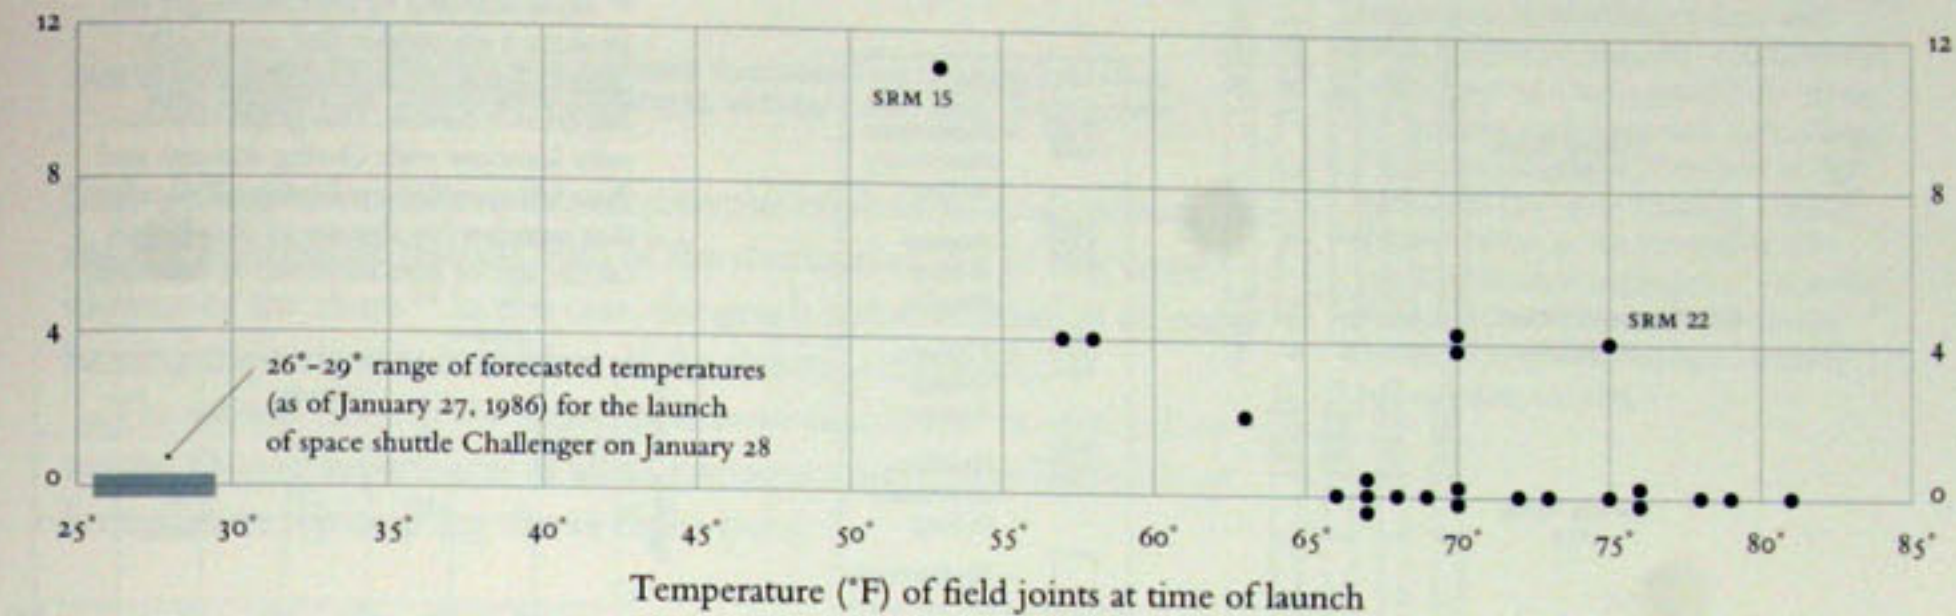
O-ring damage index, each launch

Above, a scatterplot shows the experience of all 24 launches prior to the Challenger. Like the table, the graph reveals the serious risks of a launch at 29°. Over the years, the O-rings had persistent problems at cooler temperatures: indeed, every launch below 66° resulted in damaged O-rings; on warmer days, only a few flights had erosion. In this graph, the temperature scale extends down to 29°, visually expressing the stupendous extrapolation beyond all previous experience that must be made in order to launch at 29°. The coolest flight without any O-ring damage was at 66°, some 37° warmer than predicted for the Challenger; the forecast of 29° is 5.7 standard deviations distant from the average temperature for previous launches. This launch was completely outside the engineering database accumulated in 24 previous flights.

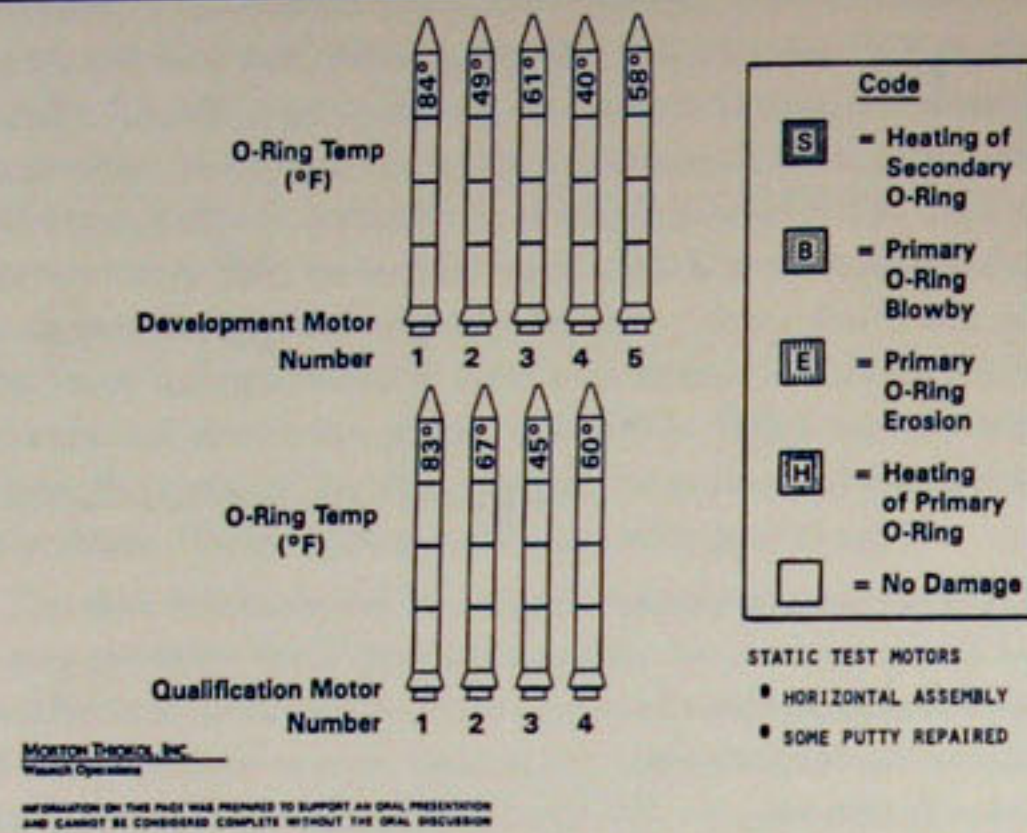
History of O-Ring Damage in Field Joints

Prepared for testimony to the commission, the chart above shows nine little rockets annotated with temperature readings turned sideways. A legend shows a damage scale. Apparently measured in orderly steps, this scale starts with the most serious problem (“Heating of Secondary O-ring,” which means a primary ring burned through and leaked) and then continues in several ordered steps to “No Damage.” Regrettably, the scale’s visual representation is disordered: the cross-hatching varies erratically from dark, to light, to medium dark, to darker, to lightest—a visual pattern unrelated to the substantive order of the measured scale. A letter-code accompanies the cross-hatching. Such codes can hinder visual understanding.

At any rate, these nine rockets suffered no damage, even at quite cool temperatures. But the graph is not on point, for it is based on test data from “Development and Qualification Motors”—all fixed rockets ignited on horizontal test stands at Thiokol, never undergoing the stress of a real flight. Thus this evidence, although perhaps better than nothing (that’s all it is better than), is not directly relevant to evaluating the dangers of a cold-weather launch. Some of these same temperature numbers for test rockets are found in a pre-launch chart that we saw earlier.

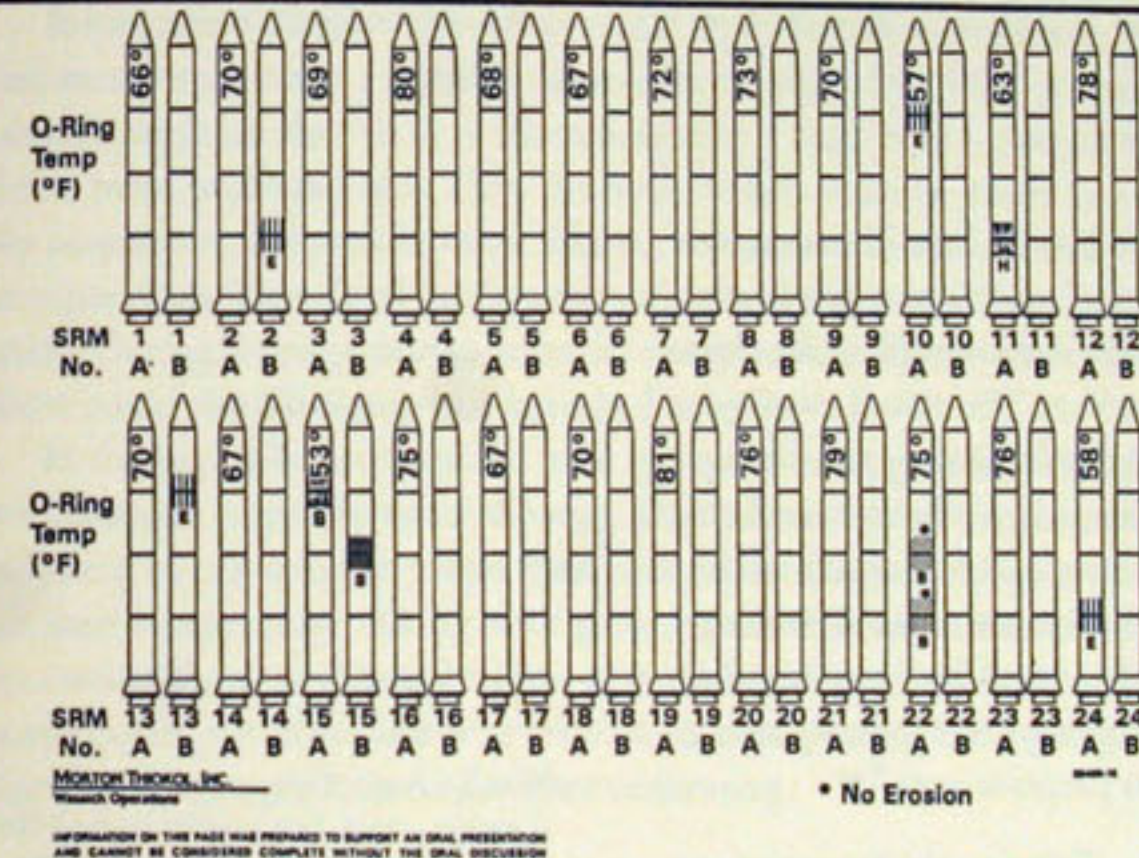
History of O-Ring Damage in Field Joints (Cont)

The second chart in the sequence is most significant. Shown below are the O-ring experiences of all 24 previous shuttle launches, with 48 little rockets representing the 24 flight-pairs:

Rockets marked with the damage code show the seven flights with O-ring problems. Launch temperature is given for each pair of rockets. Like the data matrix we saw earlier, this display contains *all* the information necessary to diagnose the relationship between temperature and damage, if we could only see it.<sup>41</sup> The poor design makes it impossible to learn what was going on. In particular:

*The Disappearing Legend* At the hearings, these charts were presented by means of the dreaded overhead projector, which shows one image after another like a slide projector, making it difficult to compare and link images. When the first chart (the nine little rockets) goes away, the visual code calibrating O-ring damage also vanishes. Thus viewers need to memorize the code in order to assess the severity and type of damage sustained by each rocket in the 48-rocket chart.

<sup>41</sup> This chart shows the rocket pair SRM 4A, SRM 4B at 80°F, as having *undamaged* O-rings. In fact, those rocket casings were lost at sea and their O-ring history is unknown.

**Lack of Clarity in Depicting Cause and Effect** Turning the temperature numbers sideways obscures the causal variable. Sloppy typography also impedes inspection of these data, as numbers brush up against line-art. Likewise garbled is the measure of effect: O-ring anomalies are depicted by little marks—scattered and opaquely encoded—rather than being totaled up into a summary score of damage for each flight. Once again Jonson’s Principle: these problems are more than just poor design, for a lack of visual clarity in arranging evidence is a sign of a lack of intellectual clarity in reasoning about evidence.

**Wrong Order** The fatal flaw is the *ordering* of the data. Shown as a time-series, the rockets are sequenced by date of launching—from the first pair at upper left SRM No. 1 1 to the last pair at lower right 24 24 (the launch immediately prior to Challenger). The sequential order conceals the possible link between temperature and O-ring damage, thereby throwing statistical thinking into disarray. The time-series

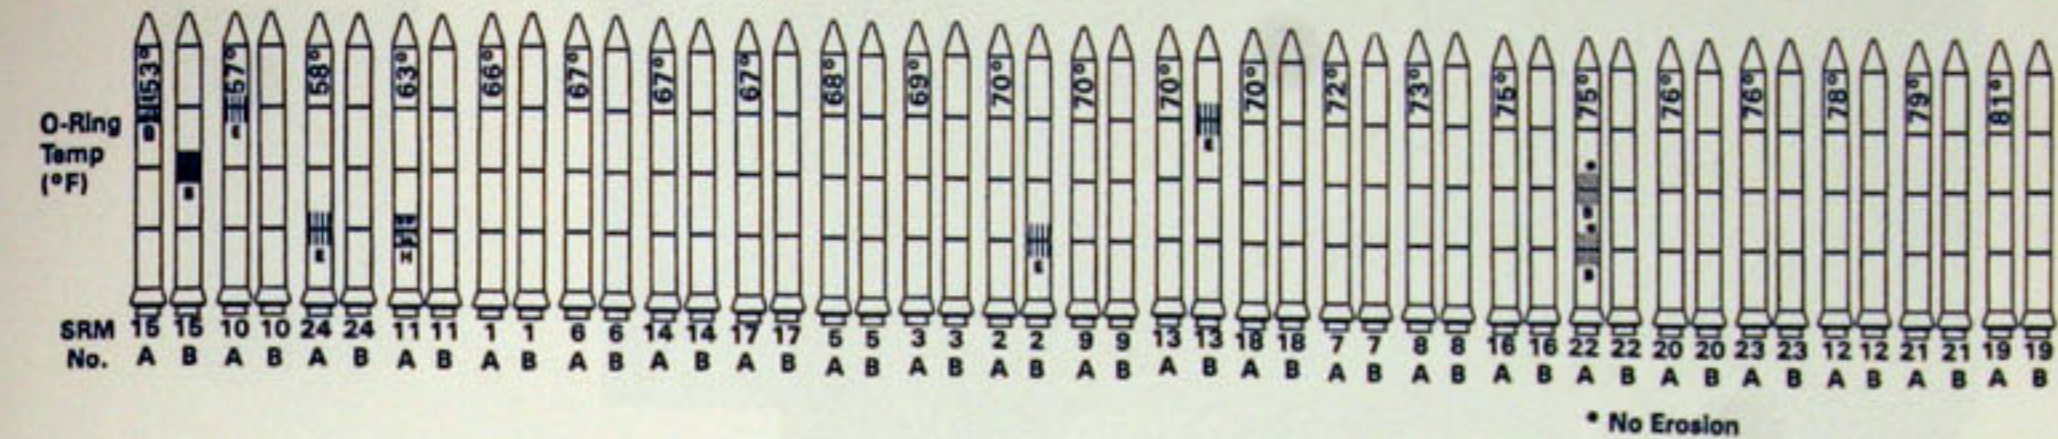
chart at left bears on the issue: Is there a time trend in O-ring damage? This is a perfectly reasonable question, but not the one on which the survival of Challenger depended. That issue was: Is there a temperature trend in O-ring damage?

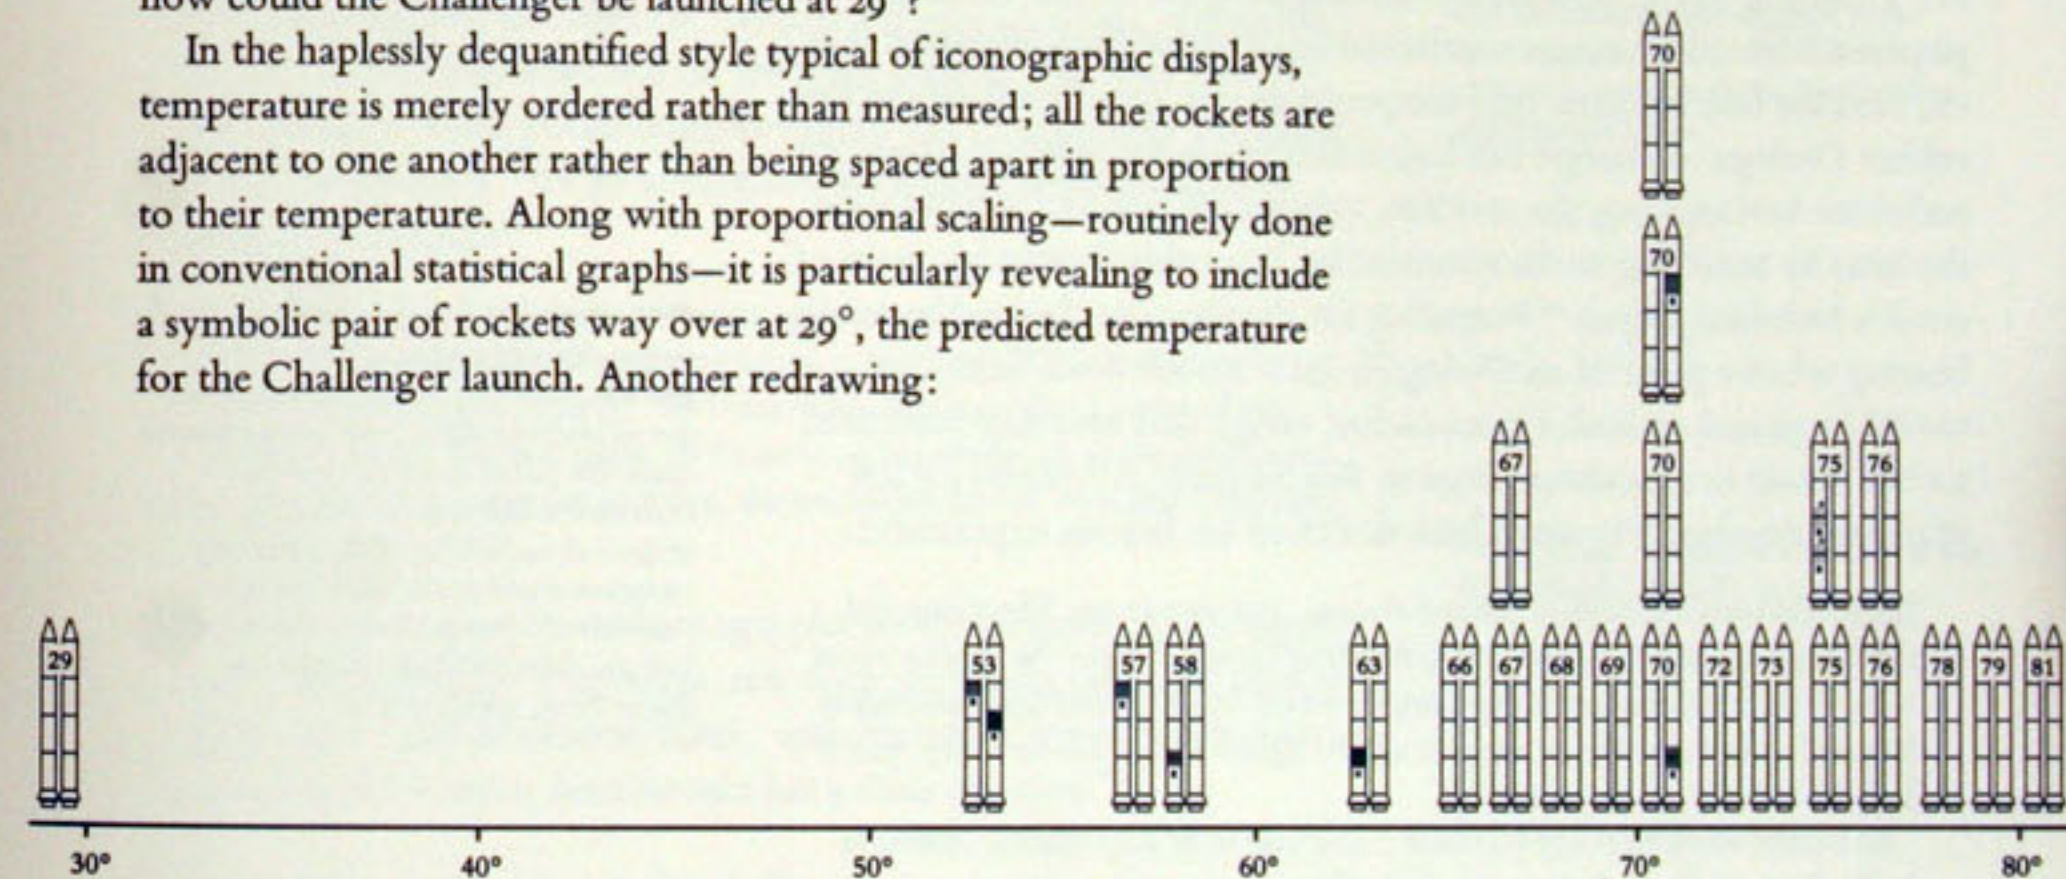
In the haplessly dequantified style typical of iconographic displays, temperature is merely ordered rather than measured; all the rockets are adjacent to one another rather than being spaced apart in proportion to their temperature. Along with proportional scaling—routinely done in conventional statistical graphs—it is particularly revealing to include a symbolic pair of rockets way over at 29°, the predicted temperature for the Challenger launch. Another redrawing:

Even after repairs, the pictorial approach with cute little rockets remains ludicrous and corrupt. The excessively original artwork just plays around with the information. It is best to forget about designs involving such icons and symbols—in this case and, for that matter, in nearly all other cases. These data require only a simple scatterplot or an ordered table to reveal the deadly relationship.

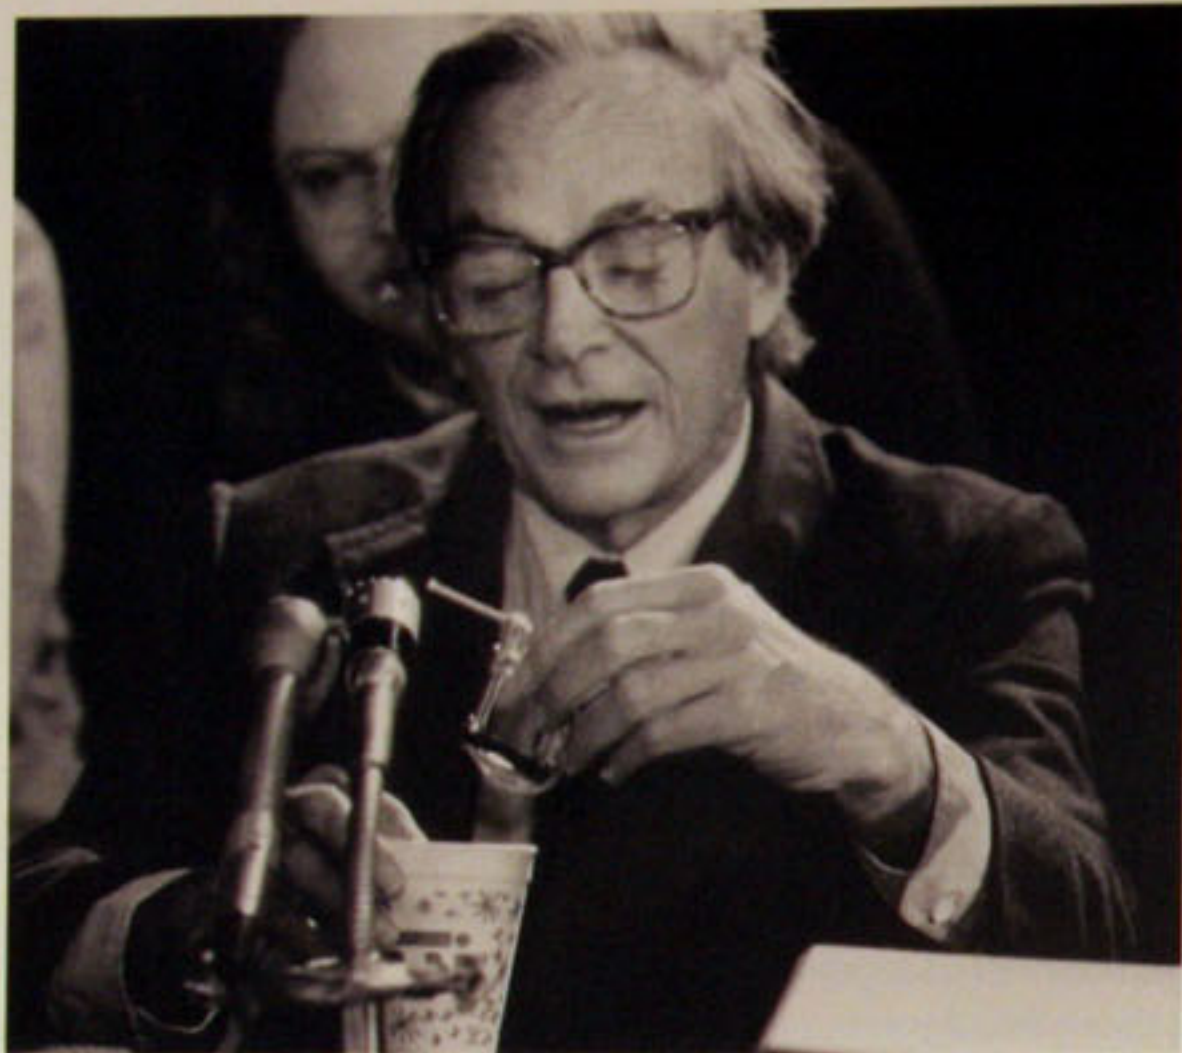
At a meeting of the commission investigating the shuttle accident, the physicist Richard Feynman conducted a celebrated demonstration that clarified the link between cold temperature and loss of resiliency in the rubber O-rings. Although this link was obvious for weeks to engineers and those investigating the accident, various officials had camouflaged the issue by testifying to the commission in an obscurantist language of evasive technical jargon.<sup>43</sup> Preparing for the moment during the public hearing when a piece of an O-ring (from a model of the field joint) would be passed around, Feynman had earlier that morning purchased a small clamp at a hardware store in Washington. A colorful theater of physics resulted. Feynman later described his famous experiment:

I take the clamp out, hold it in the air, and loosen it as I talk: "I discovered that when you undo the clamp, the rubber doesn't spring back. In other words, for more than a few seconds, there is no resiliency in this particular material when it is at a temperature of 32 degrees. I believe that has some significance for our problem."<sup>44</sup>
